DP-18-11 – Pattison

**REPORT TO THE JUAN DE FUCA LAND USE COMMITTEE
MEETING OF TUESDAY, AUGUST 16, 2011**

SUBJECT **DEVELOPMENT PERMIT WITH VARIANCE AND FLOODPLAIN EXEMPTION FOR LOT 113, SECTION 95, RENFREW DISTRICT, PLAN VIP26054**

**Riparian Area Regulation Assessment Report
947 Denewood Place, Sheringham Estates**

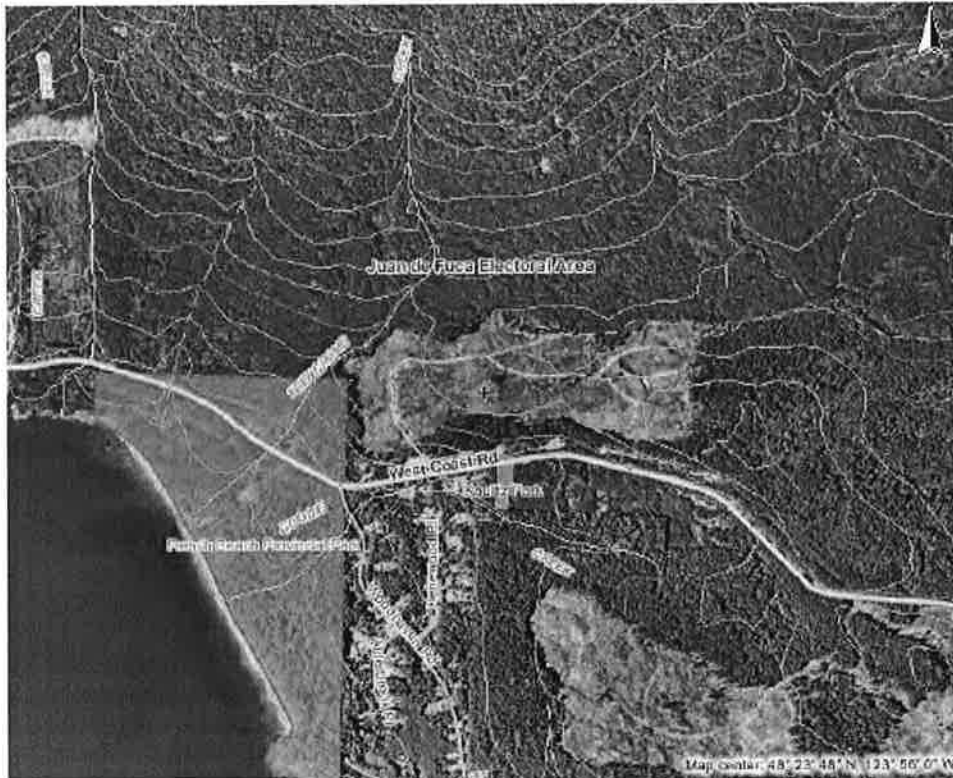
Figure 1.1 Location of Gaudie Creek; note that the stream is here labeled incorrectly as Guode Creek, and that the location is also inaccurately drawn some distance to the north of its actual course; the red X marks the approximate location of the proponent's property.

The stream on the proposed development property is named Goudie Creek (watershed code 930-033000). This stream flows roughly east to west, and empties into Juan de Fuca Strait at French Beach Provincial Park (Figure 1.1). According to the B.C. Ministry of Sustainable Resource Management Fisheries Inventory Data Queries system, the stream contains cutthroat trout (*Oncorhynchus clarkii*) in at least some parts of the system. No barriers to fish were identified in the field assessment of the property. However, no assessments for fish presence were conducted on the property, and the condition of the stream was not assessed beyond the property boundaries. The stream is therefore assumed to be fish-bearing for the purposes of this RAR report. The stream on the property consists of one hydrological reach only. It extends from a culvert under Denewood Pl., downstream to the western property boundary, approximately 150 m.

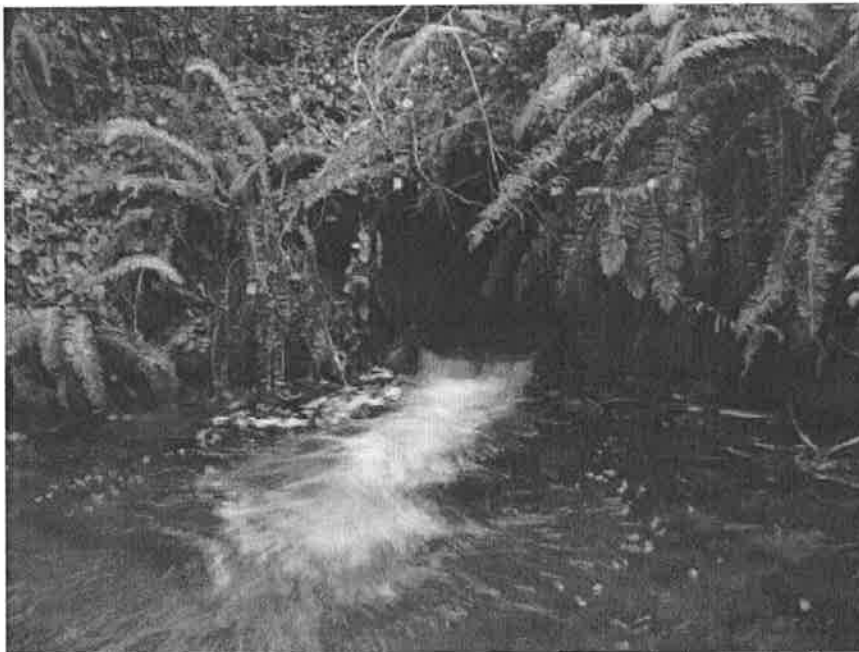
Figure 6.1 Upstream end of reach on proponent's property (culvert under Denewood Pl.)

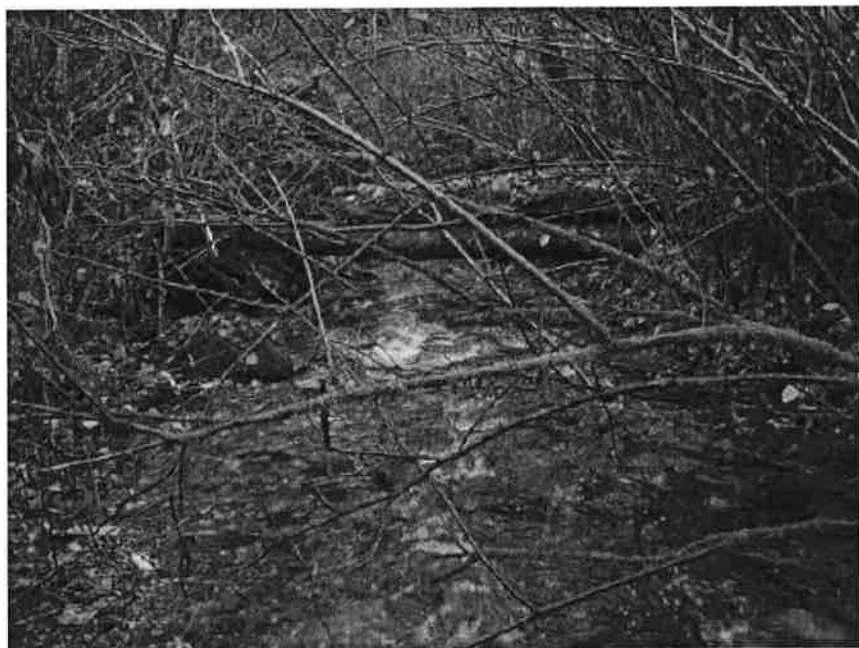
Figure 6.2 Looking downstream from upper end of reach

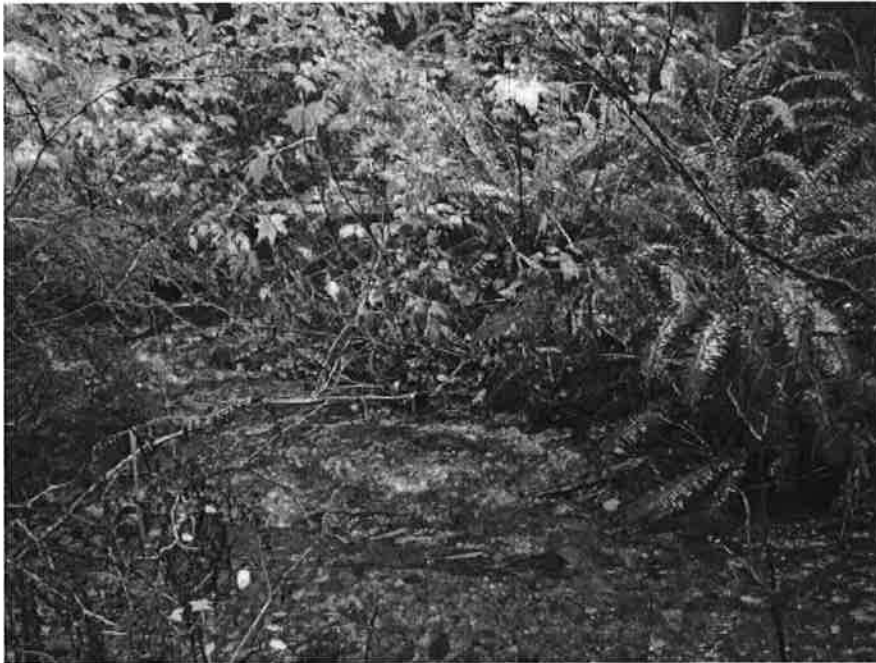
Figure 6.3 Goudie Creek, near middle of reach, illustrating healthy riparian vegetation and functional channel, near midpoint of reach

The stream channel is also in good condition with no evidence of excessive erosion, deposition, trampling or other disturbance. Abundant large wood in the stream channel is present to dissipate the energy of high flows and to maintain floodplains and habitat (see Section 6, Photographs). According to the principles outlined by Prichard (1998), the stream is in a state of Proper Functioning Condition (note that a full assessment requires an interdisciplinary team, however in this case two field biologists only employed the method). The characteristics under the categories of hydrology, vegetation and soils were present in the condition required to maintain proper function, and the stream was observed to be in balance with the landscape setting.

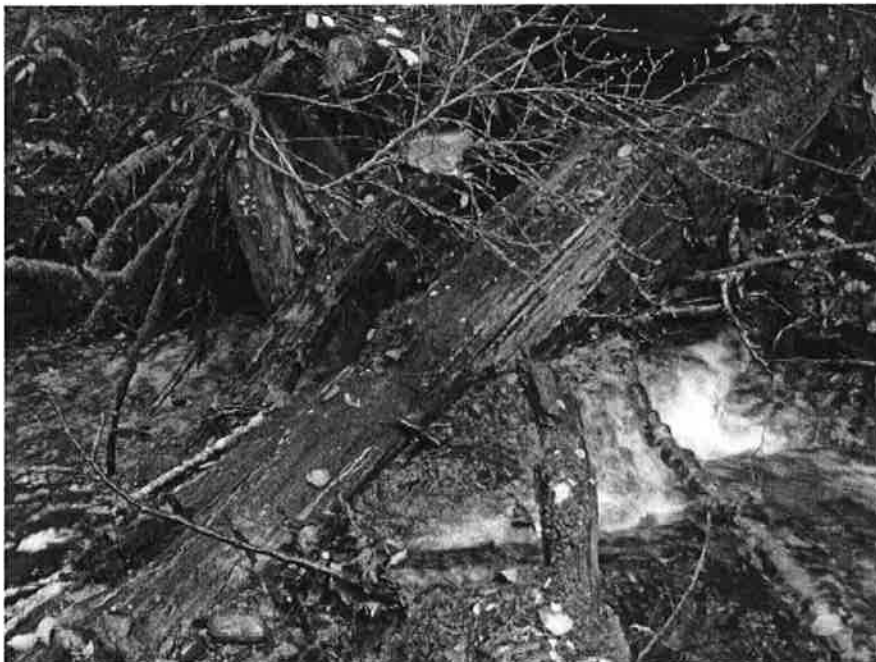
Figure 6.4 Large wood near midpoint of reach, serving to slow flows and protect banks from erosion

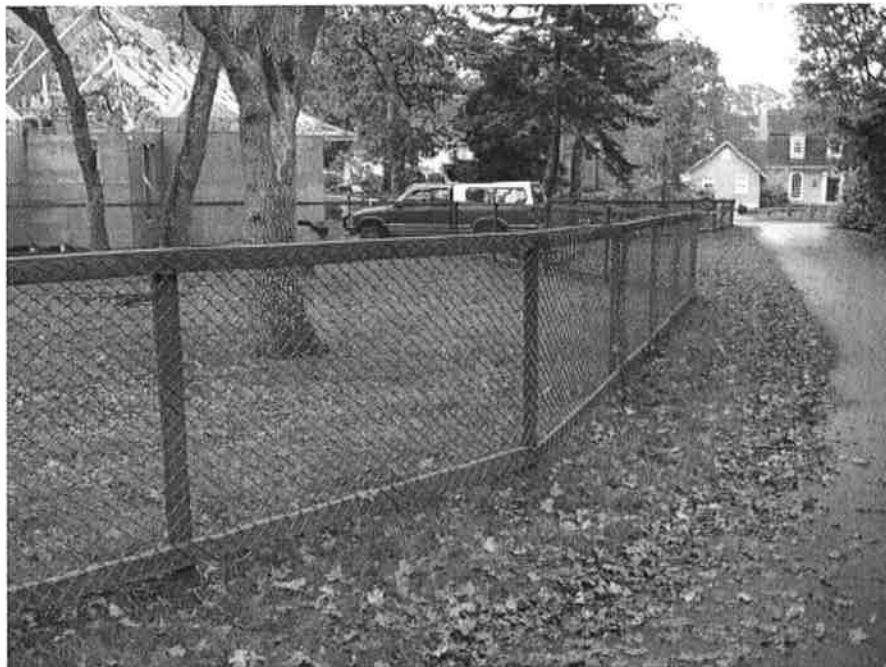
Appendix –2: Tree Protection Fencing Detail

Robust Tree Protection Fencing shall be constructed with a 2x4 frame and supports. (See photo below.) Snow-fencing will then be affixed to the frame using zip-ties, staples wire or nails. All-weather signage will be attached, clearly designating the area within as a TREE PROTECTION AREA – NO TRESPASSING.
